HOT ISOSTATIC PRESSING REJUVENATION OF DISKS

AiResearch Manufacturing Company of Arizona
111 South 34th Street
Phoenix, Arizona 85010

TECHNICAL REPORT AFML-TR-79-4093

Final Report for Period 1 September 1977 to 31 May 1979

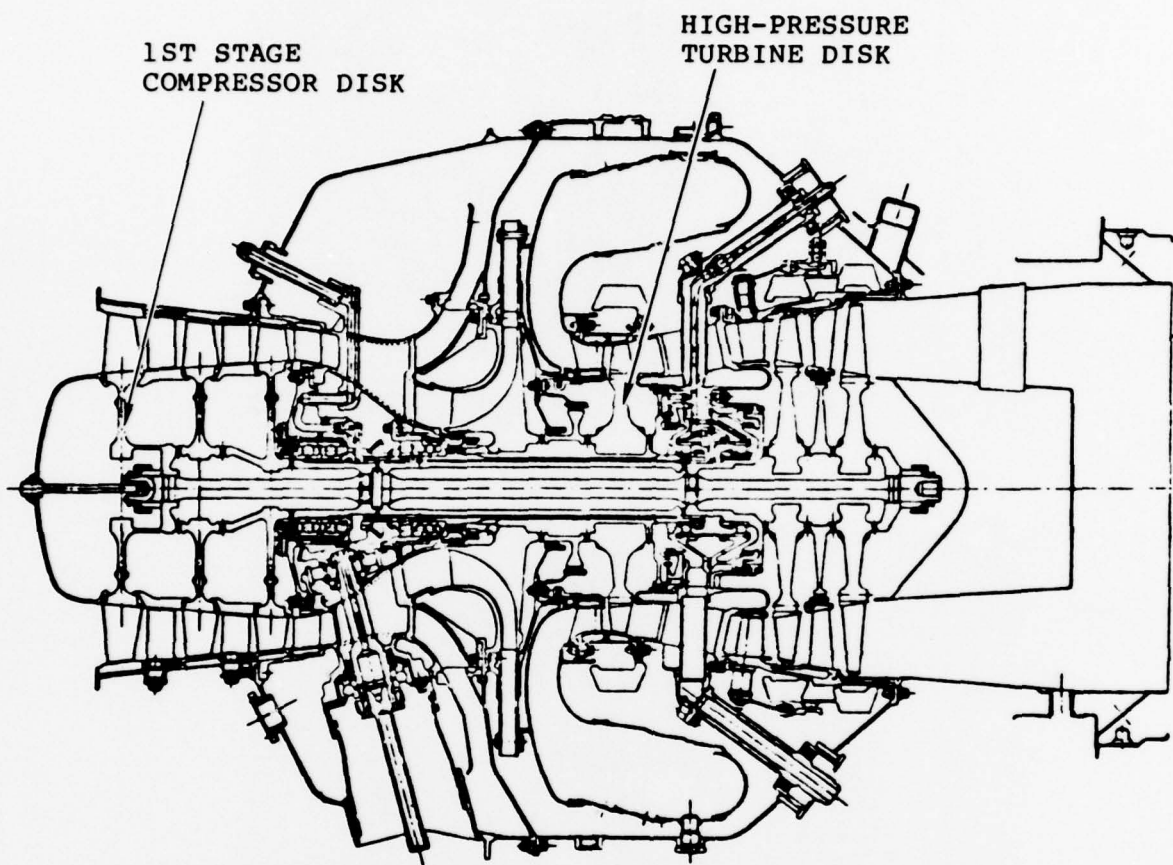
Figure 2. Retired First-Stage Compressor Disk from an AiResearch Model TSCP700 APU. Arrows Show Typical Locations of Fatigue Cracks.

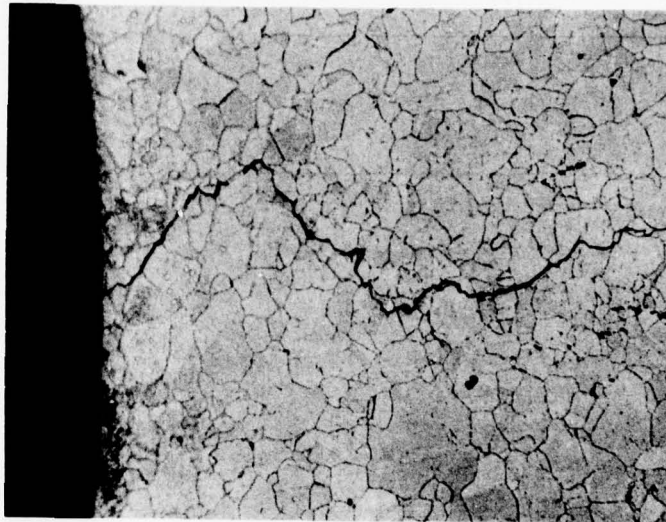
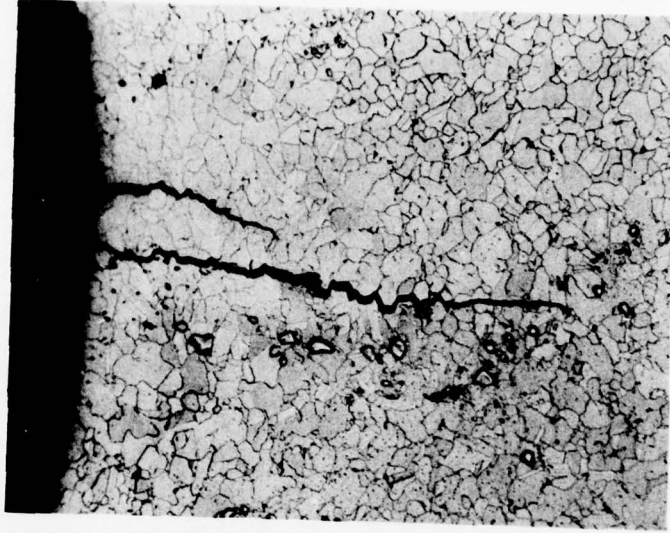
Figure 22. Low-Cycle-Fatigue Crack Produced in 6070 Cycles by Cyclic-Spin Testing at Room Temperature, Disk Serial No. 1799.

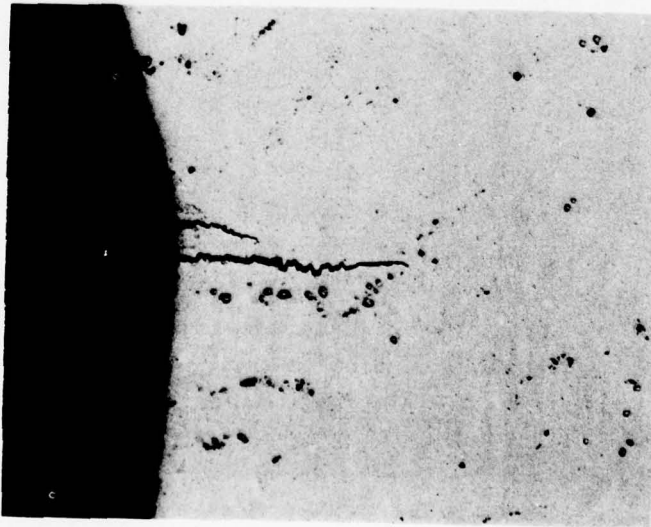
Figure 23. Low-Cycle-Fatigue Cracks Detected in Field-Service Disk Serial No. 90149A.

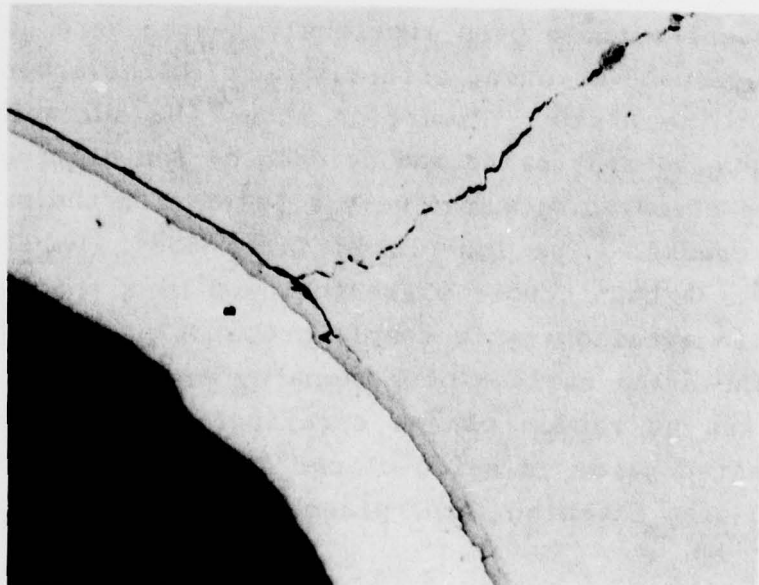
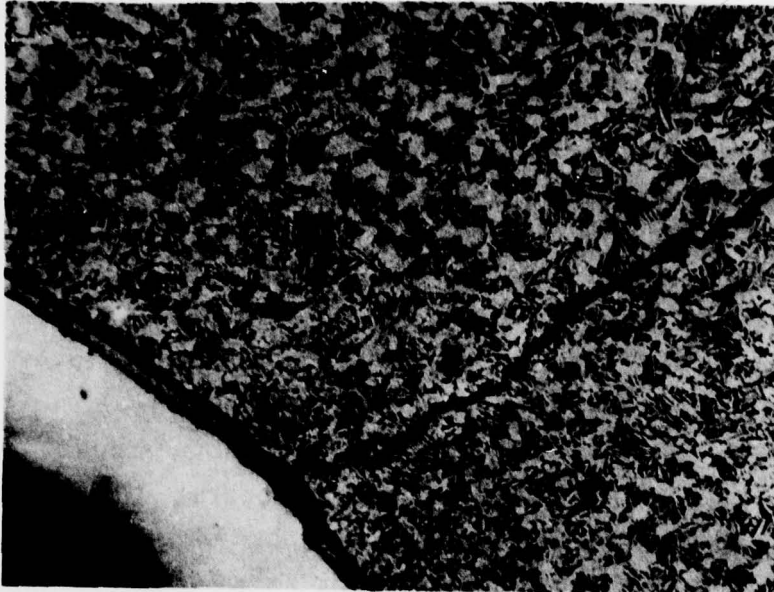
The Ti-6Al-4V and Waspaloy test samples, cleaned and bridged by vacuum plasma spraying at Electro-Plasma, Inc. and by ion plating at Koral Laboratories, were extensively examined by light metallography to determine the effectiveness of the coatings as potential crack seals (bridges). Figure 24 shows a crack in the dovetail of a Ti-6Al-4V compressor disk which has been bridged by ion plating. The titanium layer of plating is not well bonded to the substrate in the region of the crack, but different dovetails coated at the same time appeared to have the titanium layer well bonded to the substrate without the oxide film or gap. Figure 25 shows a comparable cracked dovetail bridged by vacuum plasma spraying pure titanium followed by pure copper. The titanium layer appears oxidized and quite porous compared to the ion-plated bridge. The copper layer also appears cracked and porous and probably would not act as an effective seal.

Figure 24. Dovetail Crack in a TI-6Al-4V Alloy Compressor Disk Test Sample Bridged by Ion Plating with Pure Titanium (A) and Pure Copper (B).

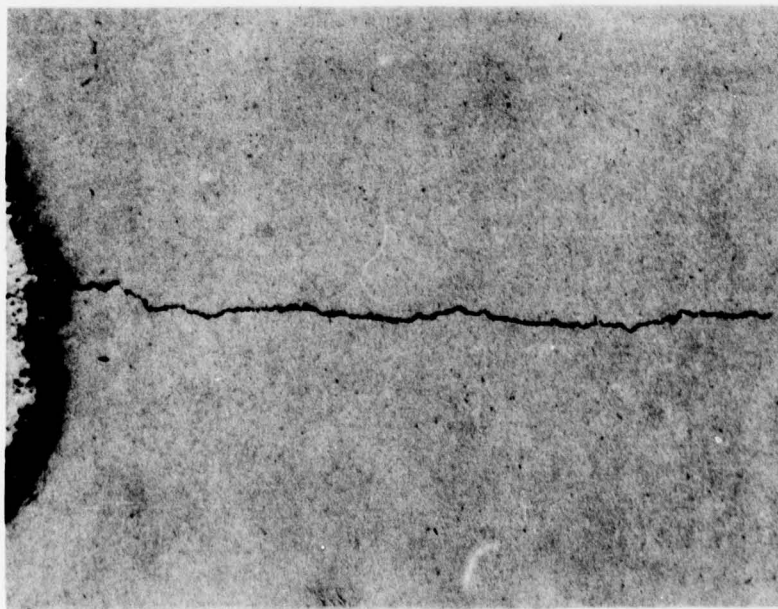
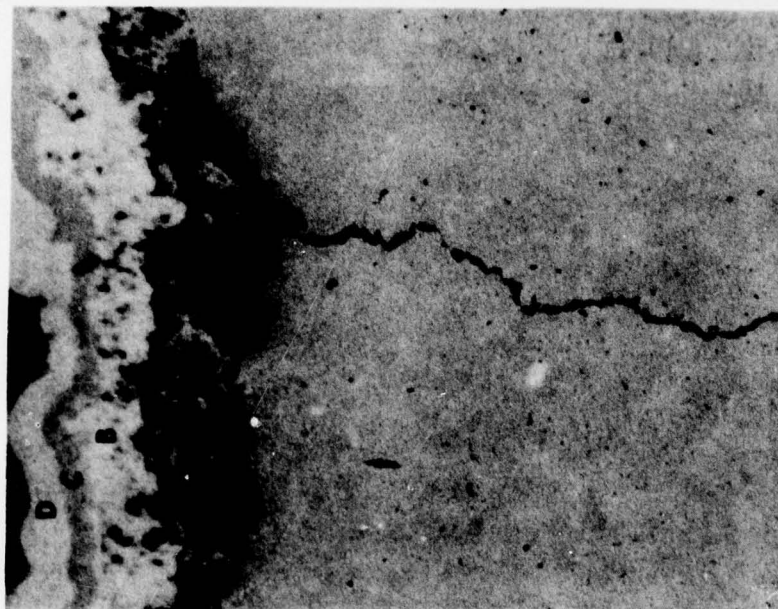
Figure 25. Dovetail Crack in a Ti-6Al-4V Alloy Compressor Disk Test Sample Bridged by Vacuum Plasma Spraying Pure Titanium (A), Pure Copper (B) and Followed by a Layer of Nickel (C) and a Layer of Copper (D) to Aid in Metallographic Sample Preparation.

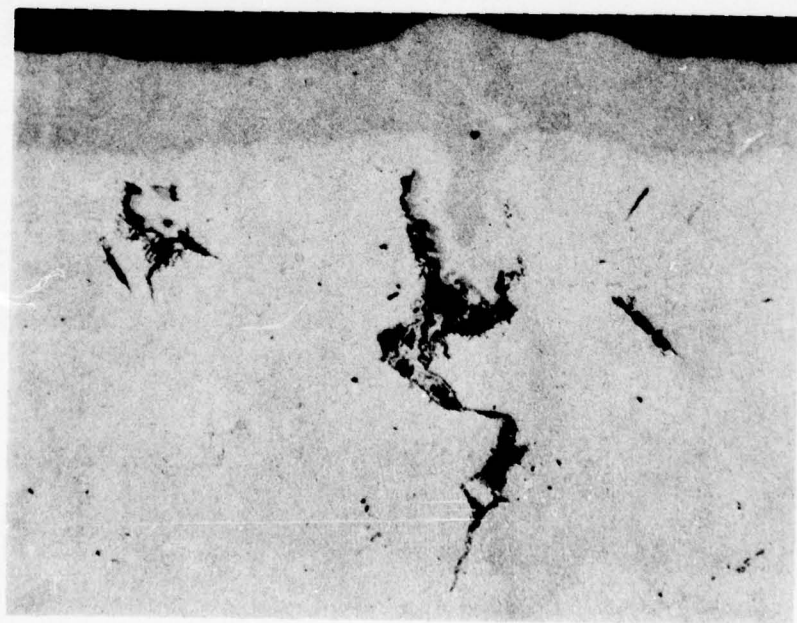
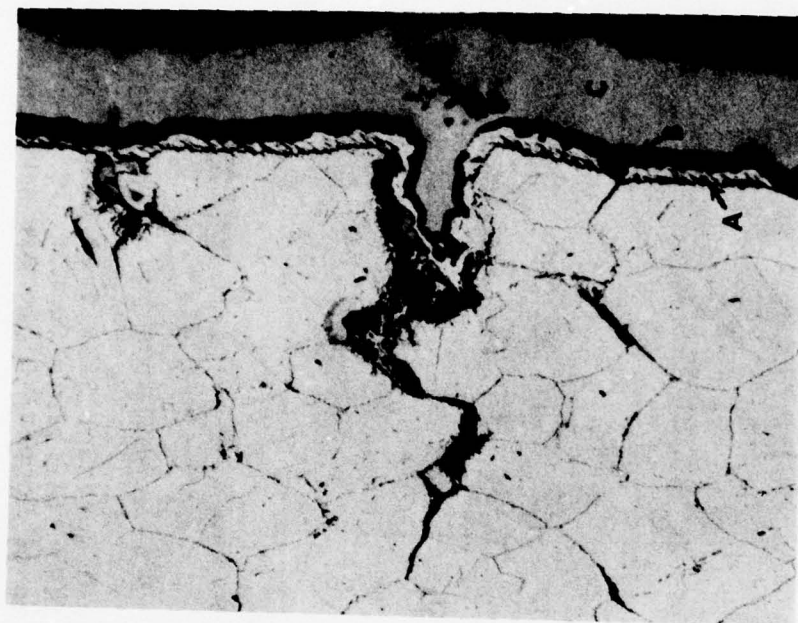
Waspaloy stress-rupture bars previously tested were used as test samples to evaluate bridging effectiveness in the absence of field-cracked turbine disks. Figure 26 shows the surface of a bar cleaned by reverse sputtering and bridged by ion plating with pure nickel. The cleaning appeared very effective on the surface but not in the cracks. The ion-plated layer does, in effect, bridge the crack. A thin copper plate followed by a thick layer of nickel aided in metallographic sample preparation. Figure 27 shows a before-and-after surface of a Waspaloy stress-rupture bar that was subjected to vacuum plasma spraying. The sample was lightly grit-blasted prior to being placed in the vacuum chamber for transferred-arc cleaning and plasma spraying with pure

Figure 26. Cracks in Waspaloy Stress-Rupture Bar Cleaned and Bridged by Ion Plating Techniques. Ion-Plated Pure Nickel (A) followed by a Flash of Copper (B) and Electroless Nickel (C). (B) and (C) Used as Sample Preparation Aids.

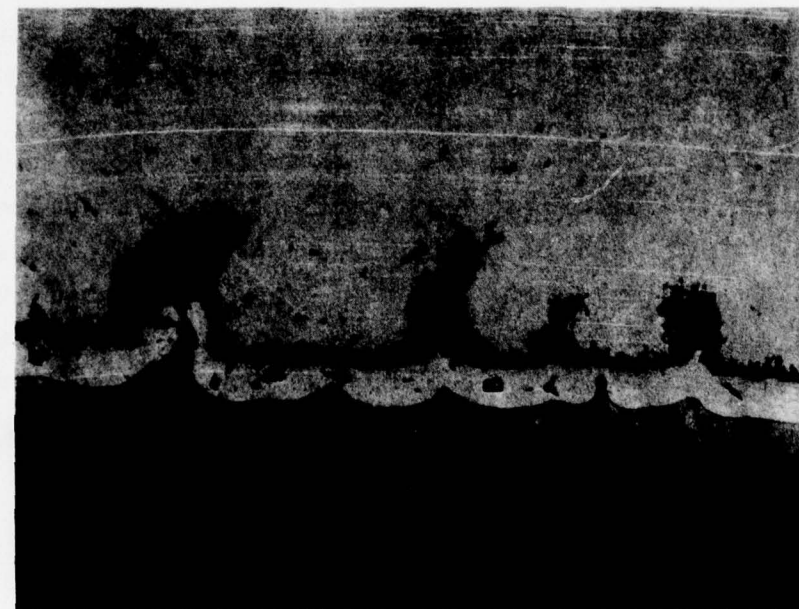
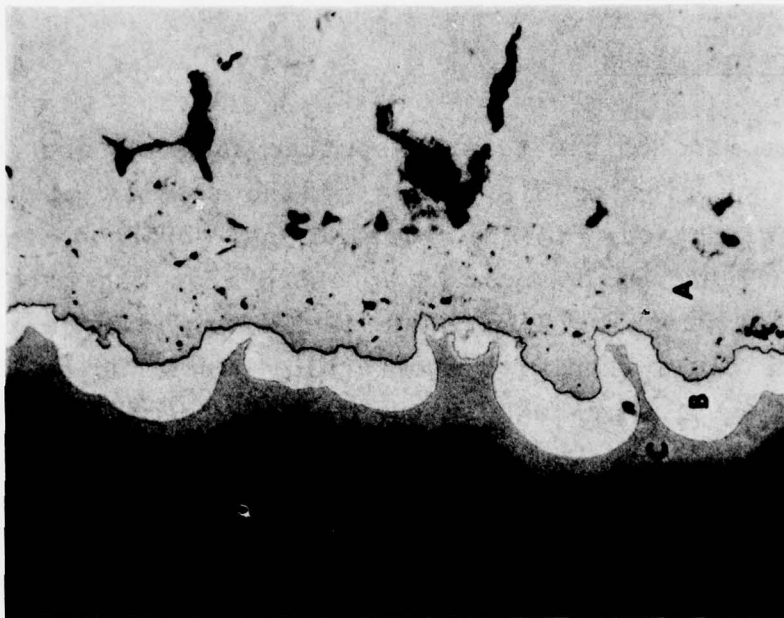
Figure 27. Surface of Waspaloy Stress-Rupture Test Bar Before (Left) and After Grit Blasting, Transferred-Arc Cleaning and Vacuum Plasma Spraying of Nickel A (Right). Copper B and Nickel C are for Metallographic Sample Preparation.

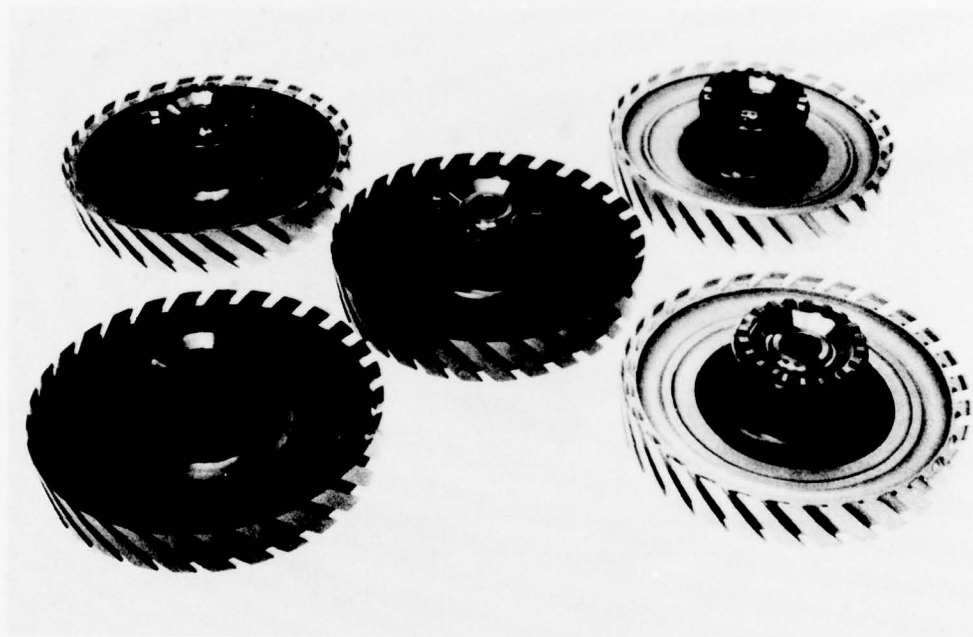
Figure 28. Five TSCP700 Compressor Disks Which Have Been Reverse-Sputter Cleaned and Ion Plated with Pure Titanium Followed by a Flash of Copper. MAG: $\sim 0.3X$.

The Ti-6Al-4V alloy compressor disks were ion plated with a 0.001- to 0.002-inch thick layer of pure titanium followed by a 0.001-inch thick layer of copper on the blade attachment dovetails of five field-service compressor disks. Reverse sputtering was employed prior to plating to clean the surfaces. The work was accomplished at Koral Laboratories, St. Paul, Minnesota. Figure 28 shows the five compressor disks after bridging. The light-colored regions encompassing the dovetails and part of the web are the copper plate which was applied over the layer of pure titanium. Additional copper was subsequently electroplated over the flash of copper shown here prior to shipment for HIP.

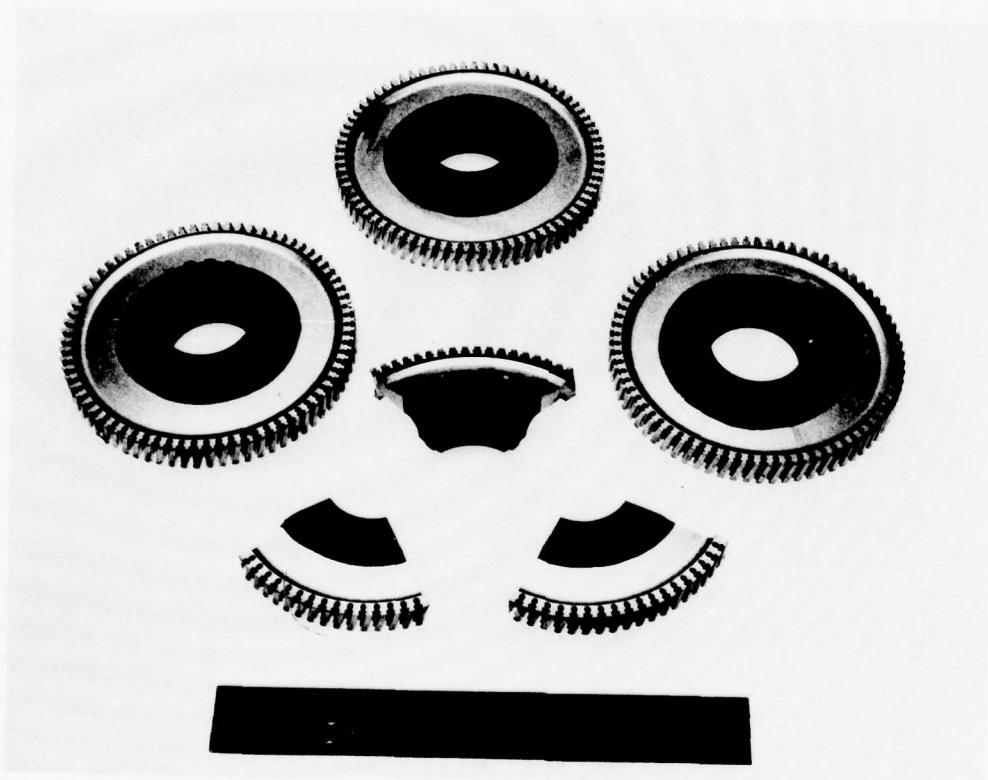
Figure 29. Turbine Disks and Disk Sections Ion Plated with Pure Nickel Prior to HIP.

Six Waspaloy turbine disks and disk sections were ion plated with approximately 0.002-inch of pure nickel at Koral Laboratories. The disks and disk sections are shown in Figure 29. Additional nickel (0.003 to 0.005 inch) was electroplated over the ion plate layer to build up the bridge over the fatigue cracks.

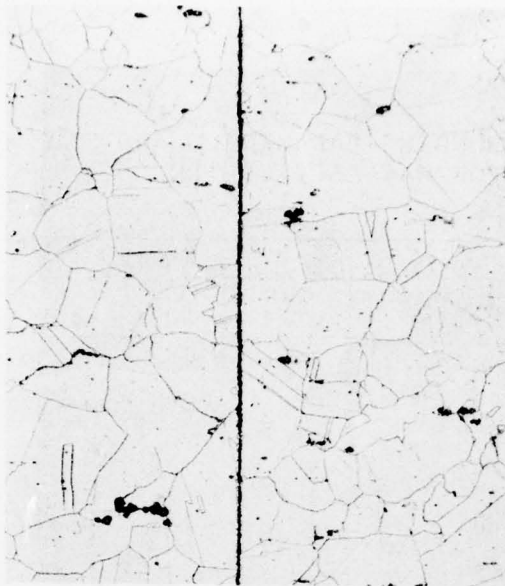
At bonding temperatures above 1800°F, grain growth was observed which contributed to the reduced strength of samples bonded under these conditions. Figure 36 is a photomicrograph showing the increase in grain size exhibited by the 1900°F/4-hours/5-ksi specimens over those bonded at 1800°F. The latter specimens experienced essentially no grain growth.

Figure 36. Photomicrographs Showing Grain Growth Experienced by 1900°F/4-hr/5-ksi Bond Specimen (After Heat Treatment).

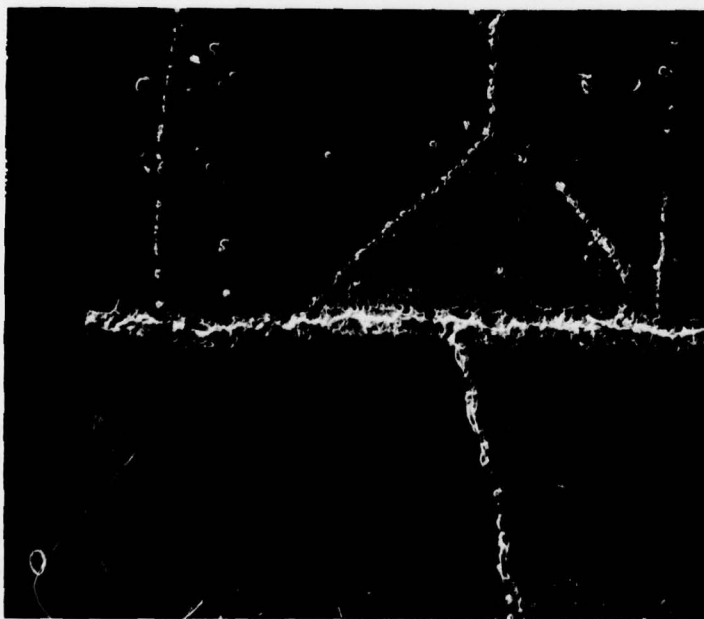
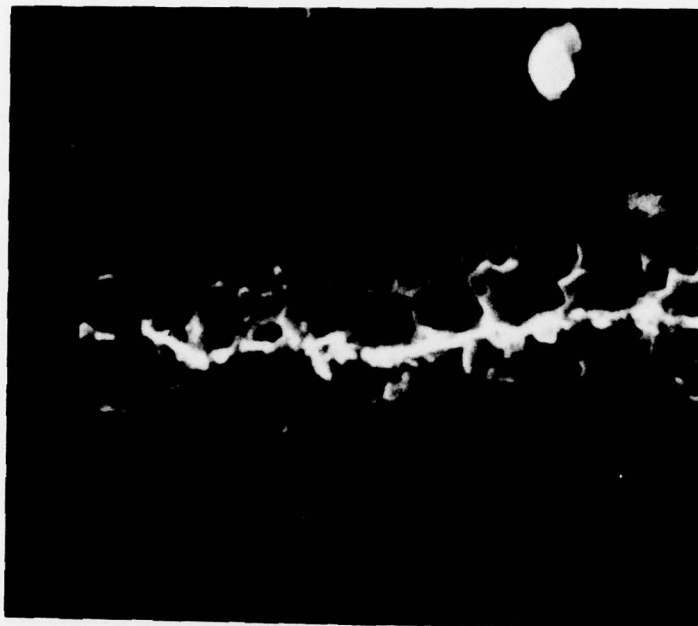
The apparent reason for the observed decrease in ductility of the bonded specimens, versus the baseline unbonded specimens, was the presence of a continuous oxide film at the bond interface (refer to Figure 37). Scanning-Electron-Microscope (SEM) analysis of the film revealed it to be high in aluminum and titanium. Another feature of the bond area was the presence of a narrow band of recrystallized grains denuded of gamma prime. This apparently resulted from the cold work introduced during the grinding and lapping of the bond specimen surfaces prior to joining, and should not occur in cracked and rejuvenated hardware.

The depletion of gamma prime in the grains adjacent to the bond line indicated that aluminum and titanium in this area reacted with available oxygen to form the observed oxide interlayer. Since a high vacuum was maintained during the bond cycle,

Figure 37. SEM Photomicrographs of Typical Bond Joint Showing Aluminum/Titanium Oxide Interlayer. Note Recrystallization Adjacent to Bond.

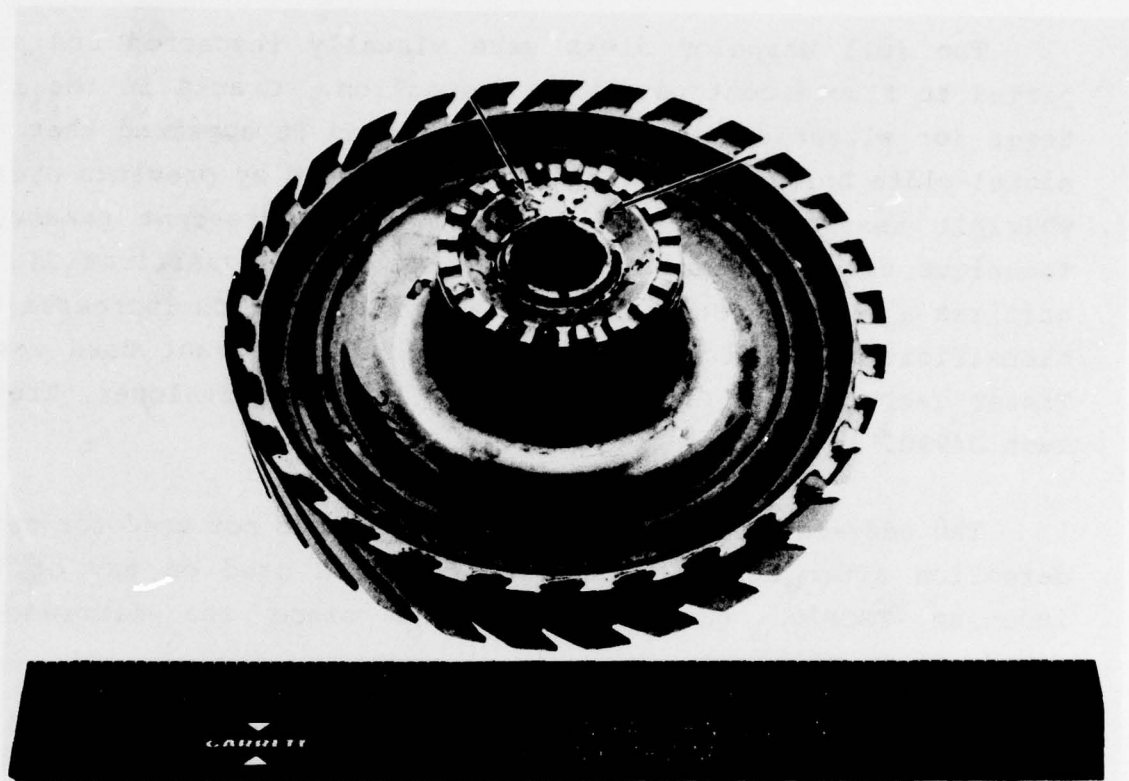
MAG: 1/2X

A pitting-type corrosion was noted in regions that had been electroplated with copper but had not been first ion plated. Figure 39 shows this corrosion in the region of the curvic coupling. The possibility exists that electroplating solution was trapped between the disk surface and the heavy copper plate due to poor adherence, and upon heating, corrosion of the Ti-6Al-4V occurred.

Figure 39. Ti-6Al-4V Alloy Compressor Disk After HIP and Copper Plate Removal. Note Corrosion (arrows).

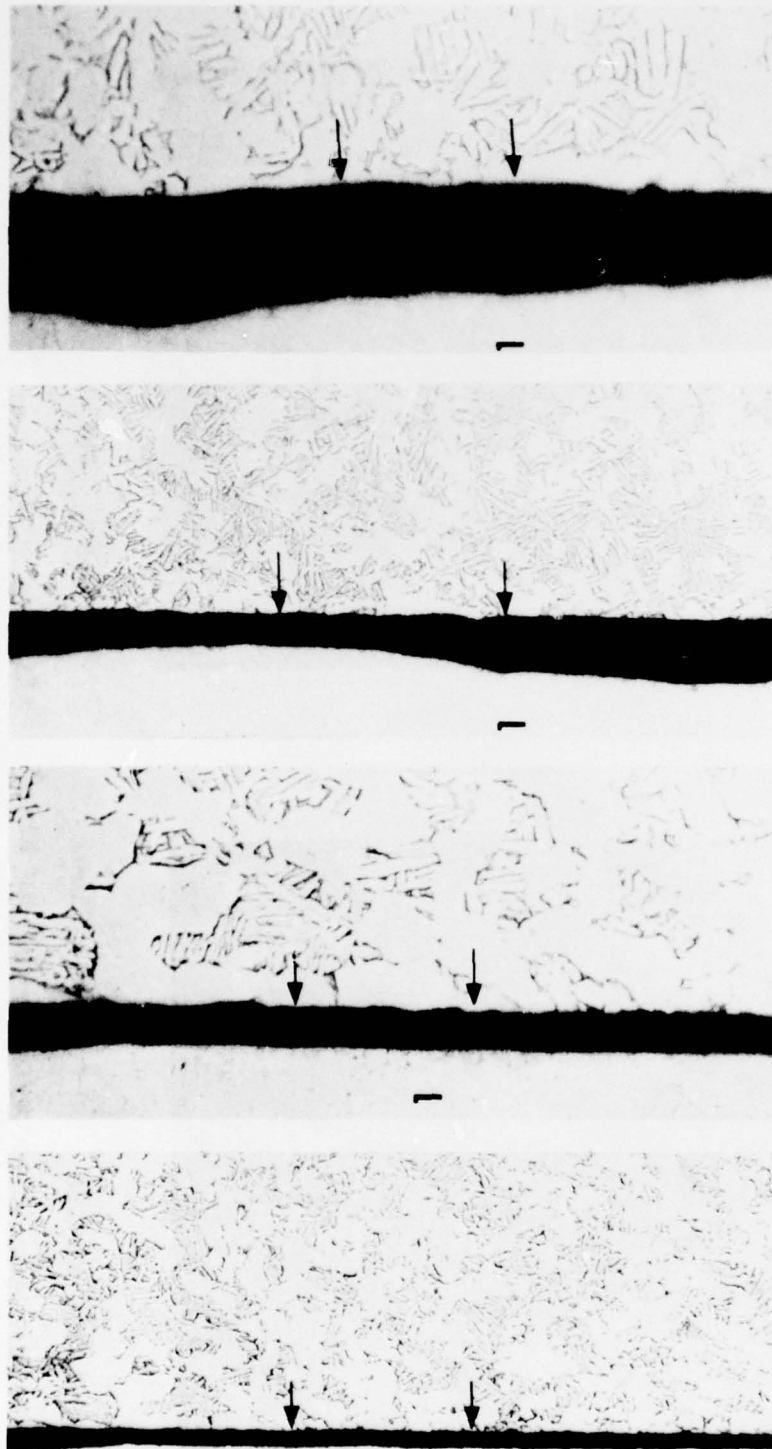
Careful metallographic examination was given to the surface of the disks that were not bridged prior to HIP to determine if contamination or stabilized alpha case had occurred. Figure 45 shows both the OD and a portion of the dovetail base of disk Serial No. 4774. Note that there is no evidence of alpha case or visible surface deterioration indicating an inert HIP atmosphere.

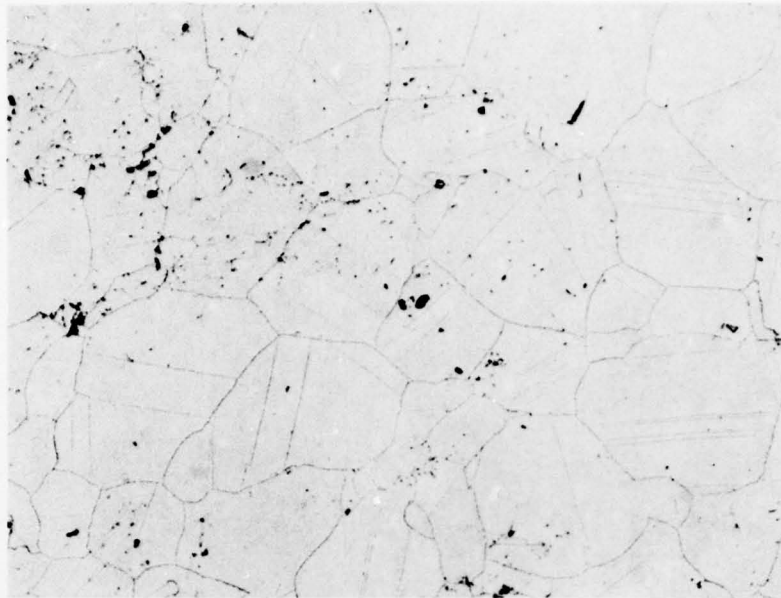
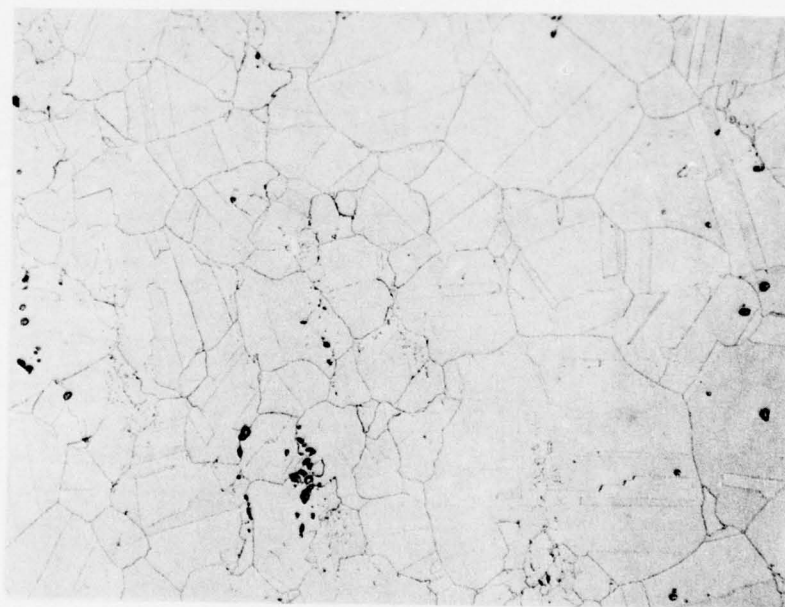
An extensive metallographic examination of the HIPped and heat-treated Waspaloy disks was performed. Figure 48 shows the microstructure comparison of both the pre- and post-HIP of disk Serial No. 1351. The grain size was slightly enlarged by the HIP and subsequent heat treatment but remained in the acceptable range. Figure 49 shows photomicrographs of a

Figure 48. Pre-HIP and Post-HIP Microstructures of Waspaloy
Disk Serial No. 1351 Etchant: Kallings
MAG: 100X

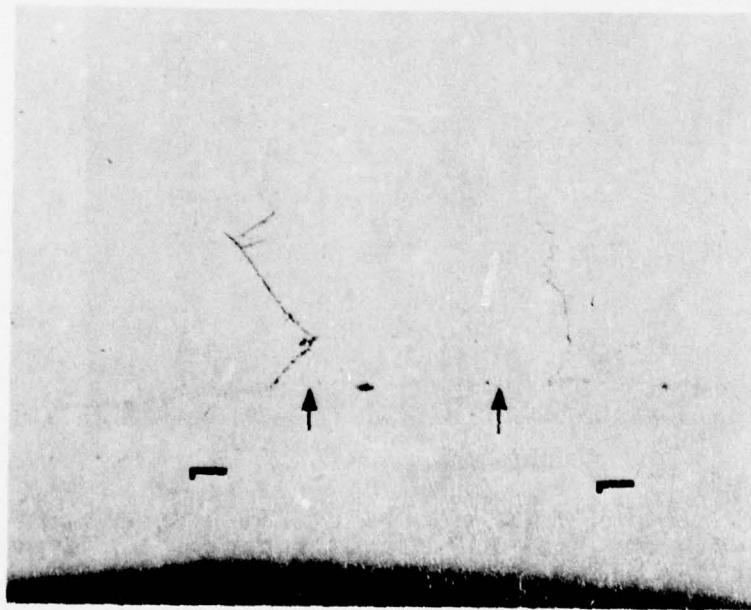
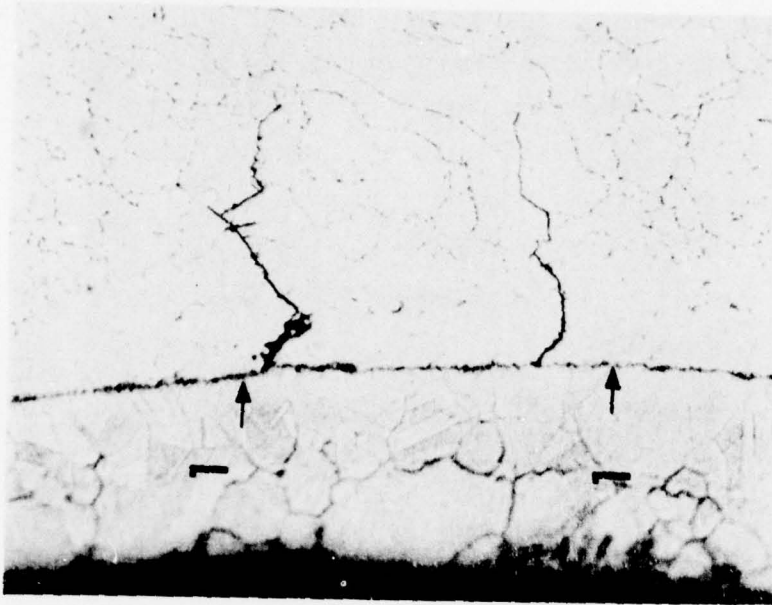
Figure 49. Base of Firtree in Waspalloy Turbine Disk after HIP and Heat Treatment.
Cracks are Bridged with Pure Nickel (Layer 1) Bridge to Form a Seal
During HIP. Mag.: 400X

section made through the base of a fir-tree of a field-service disk. This particular blade slot exhibited cracks that were produced in service and were subsequently bridged with nickel prior to HIP. Note the cracks are bridged but HIP did not create a bond. Denuding of the gamma prime below the original disk surface is evident. The aluminum and titanium appear to be diffusing into the pure nickel plate leaving the Waspaloy deficient in the alloying elements.

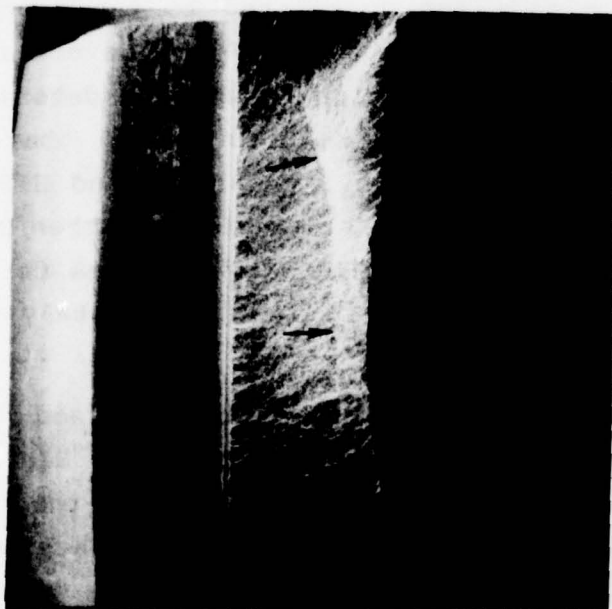
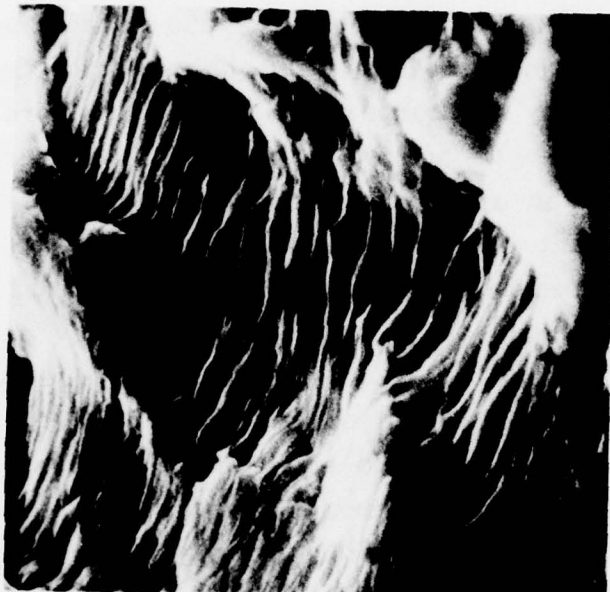
To substantiate this hypothesis, cracked dovetails were broken open and the surfaces were examined on the SEM. Counts of the number of cycles were made and correlated to the depth of crack propagation. (Figure 54 shows a typical fatigue striation photograph.) From this data, propagation rates were determined for un-HIPped and HIPped disks. The results showed that the rates were similar for both cases, i.e., un-HIPped and HIPped. Therefore, if the crack propagation rates are similar, then crack initiation occurs sooner for the post-HIP material than for the un-HIPped material, since the life ratio is approximately one-half.

The early crack initiation could have been caused by a number of conditions; (1) surface contamination during HIP, (2) chemistry changes on the surface, and (3) relaxation of the residual stresses caused by the original machining and broaching of the disk dovetails. To investigate these possibilities, detailed Scanning Electron Microscope (SEM) analyses, Auger Spectroscopy,

Crack in Dovetail No. 15.

A Designates Location
of Image 2.

Arrows Show Progression of
Fatigue Crack.

Fatigue Striations
Estimated at 75,000/inch

Figure 54. Location of LCF Crack and SEM Image of Fatigue Striations. Disk S/N 4873 (New Disk Baseline).

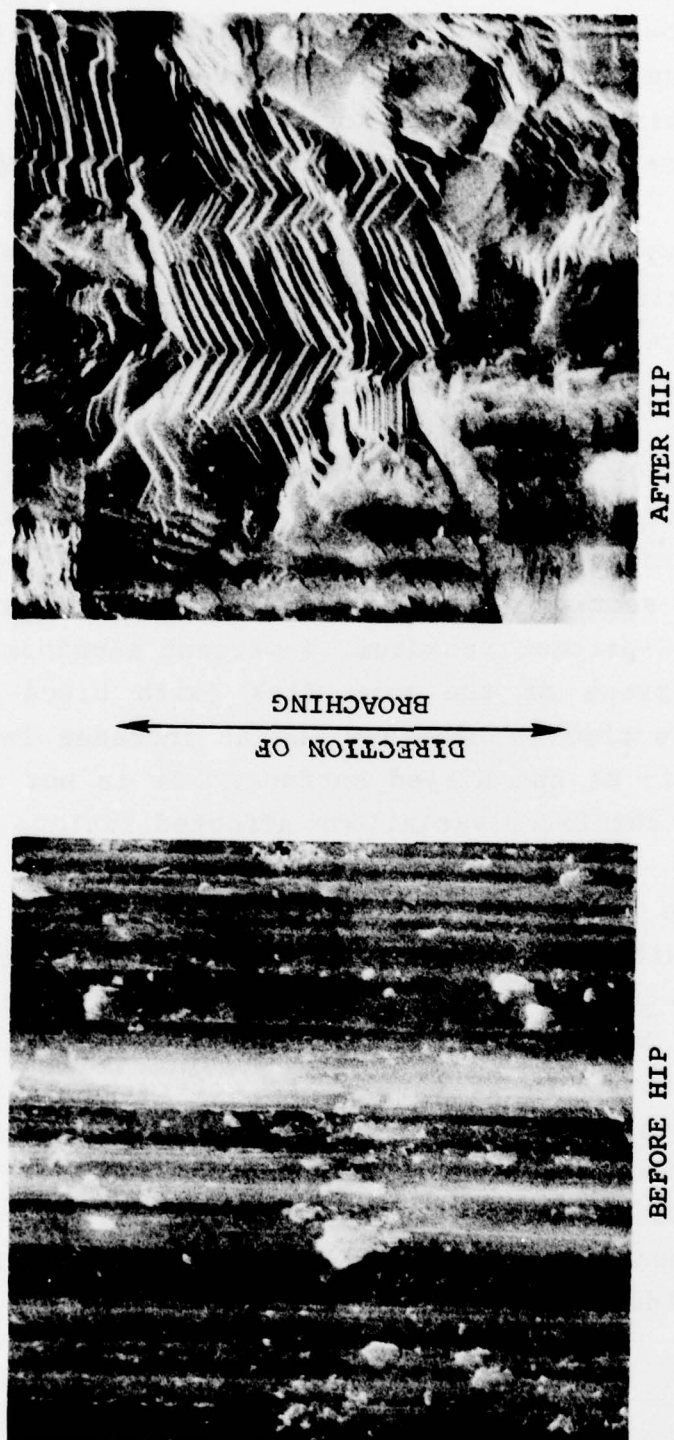
and X-ray residual stress measurements were performed on un-HIPped and HIPped disk samples. SEM analysis of the broached dovetail surface indicated a surface change occurred during HIP. Figure 55 shows before and after photographs indicating that most of the residual broach marks were removed by a thermal etching or thermal faceting. It was not known to what degree this thermally etched surface might affect fatigue crack initiation.

Figure 55. SEM Analysis of Dovetail Surface Before and After HIP.
Mag.: 5000X

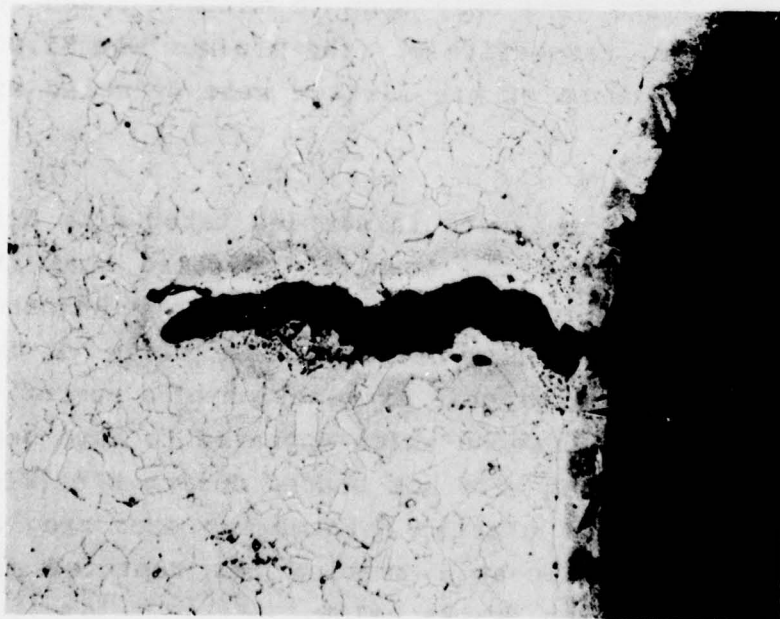
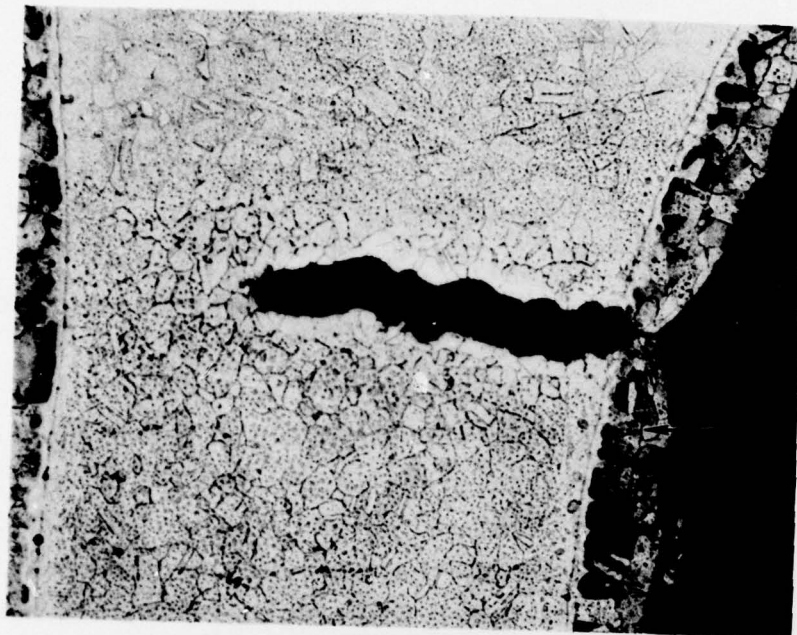
The first bridged disk, Serial No. 2685, which had been spin tested prior to HIP, was cycled in steps of increasing speed to monitor bore growth. After eleven cycles (maximum speed of 53,100 rpm), cracks were detected at the base of the firtrees in locations matching those present prior to bridging, HIP, and heat treatment. Subsequently, field-service disks (Serial Nos. 90309 and 727), which had exhibited cracks prior to bridging and HIP, were spun. These two disks were only spun to maximum speeds of 51,800 rpm and 52,200 rpm, respectively, (the minimum was 52,900 rpm) before cracks at the base of the firtree were detected and the disks were retired.

Tensile properties were measured in samples taken from disk Serial Nos. 90309 and 727, and the results indicated that the strengths of the disks were acceptable according to AiResearch specifications, and exceeded those reported in Table 21 for the post-HIP material. Metallographic examination of a number of cracked firtrees showed large cracks which appeared to have been bridged by the nickel plate but were not bonded during HIP (Figure 56). It appears that the plastic deformation occurring at the firtree base during cyclic-spin testing has ruptured the bridge and exposed the existing cracks below.

Figure 56. Cross Section of the Bases of Two Firtrees After Bridging with Nickel, HIP, Heat Treatment, and Spin Testing. Etchant: Modified Kallings. Mag.: 100X. Arrows Indicate Nickel Bridge.

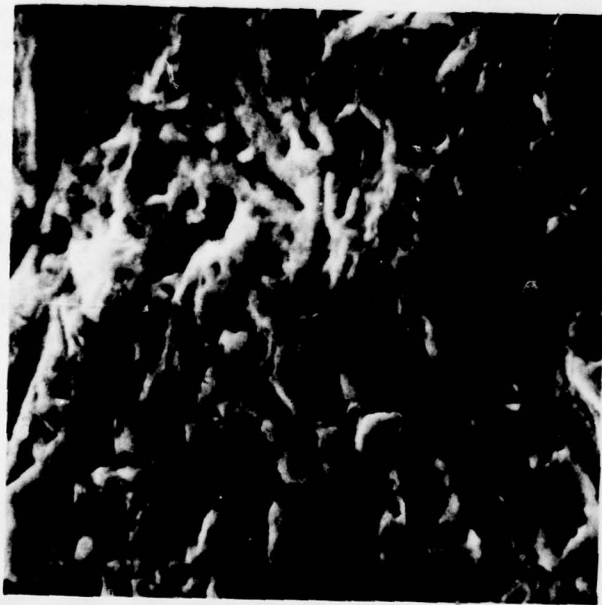
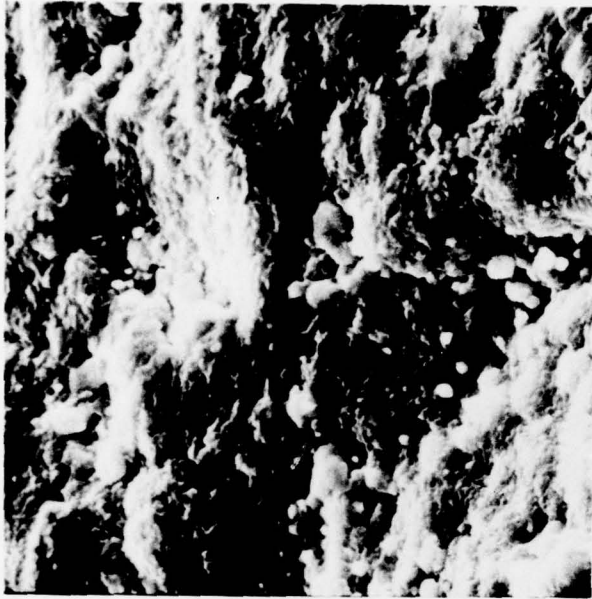
Figure 58 shows the appearance of the surface of Waspaloy in the SEM before and after HIP. The area is just below the base of the firtree and was oxidized in engine service. The HIPped surface shows additional oxidation present but it is not considered detrimental.

Figure 58. Appearance in the SEM, of Waspaloy Before and After HIP.
Mag.: 5000X
